The Northern Chaco Outliers Project 2017 Field Report

Period covered by this report: 2017 Field Season

The Northern Chaco Outliers Project Annual Report, 2017 Field Season

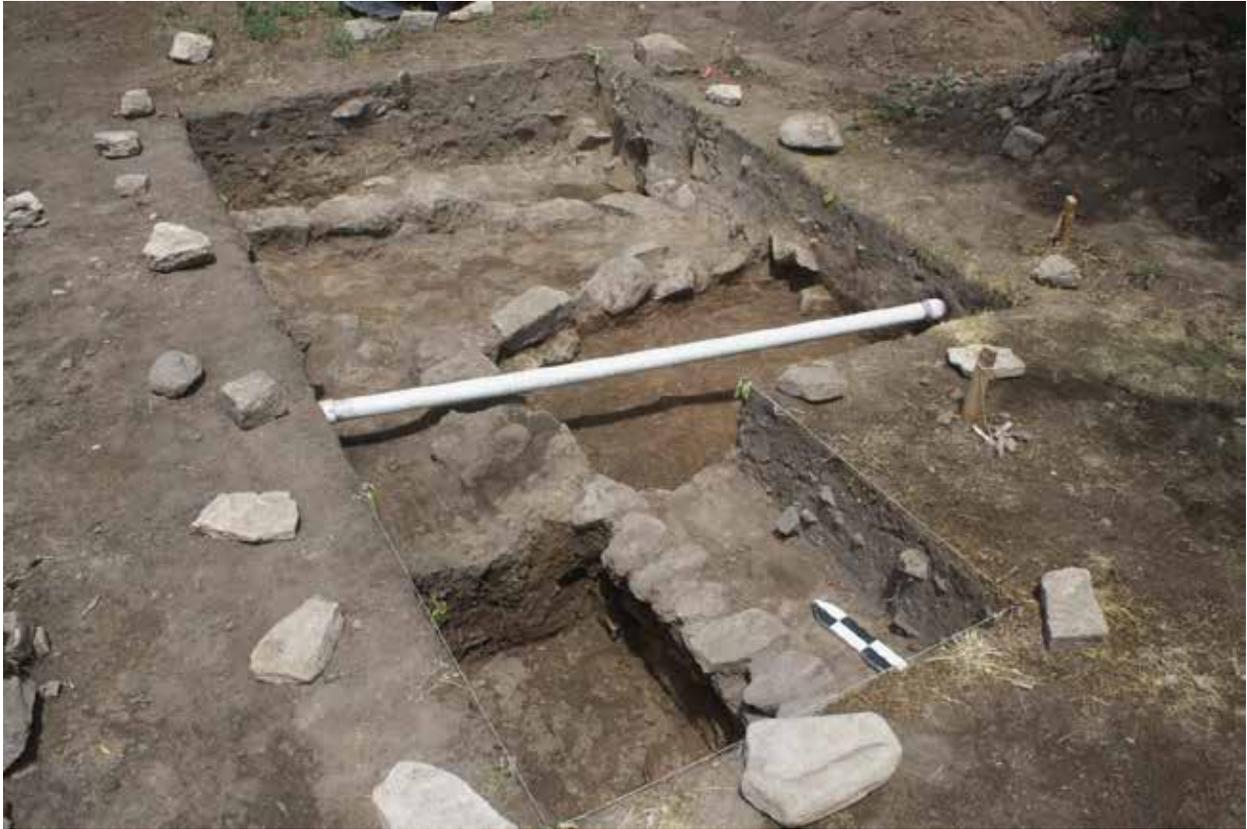
Figure 5. Excavation in progress of wall and roof fall in Structures 186 and 193 (view northeast), the Haynie site.

Located west of the modern house, Structure 186 (Figure 5 and Figure 6) is a room featuring single-coursed masonry. A wall segment, which was identified in a 2-x-2-m unit and a 1-x-1-m unit, had been constructed using irregularly shaped sandstone rocks and mortar. The installation of a modern laundry-drainage pipe had damaged the wall and disturbed the fill in the room. Structure 186 appears to be a detached room constructed within, and possibly using the remains of, an earlier structure (Structure 193). The floor is unplastered construction fill. We infer that the remainder of the room is damaged and that the damage was caused by the roots of a nearby apple tree and by additional activities related to modern occupation. Excavations will continue in this structure in 2018.

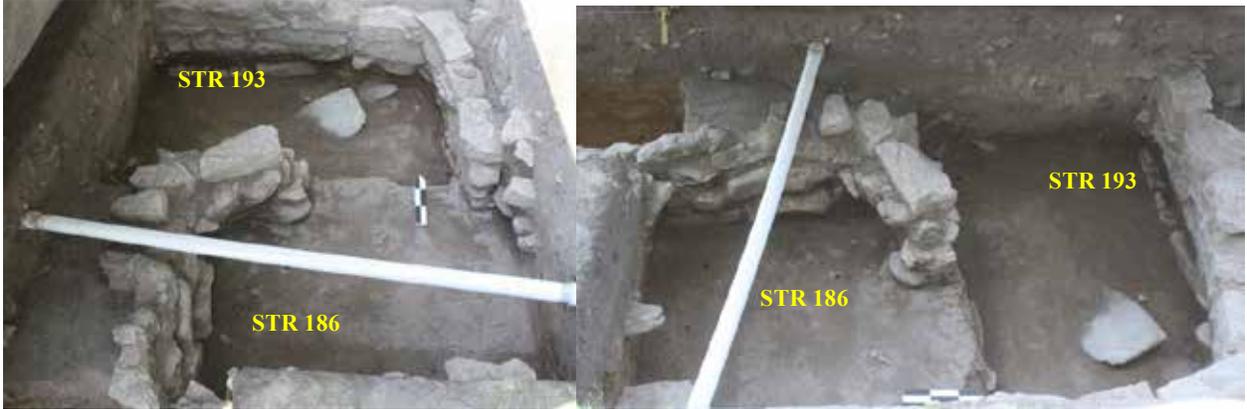
Figure 6. North and west oblique views of Structures 186 and 193, the Haynie site.

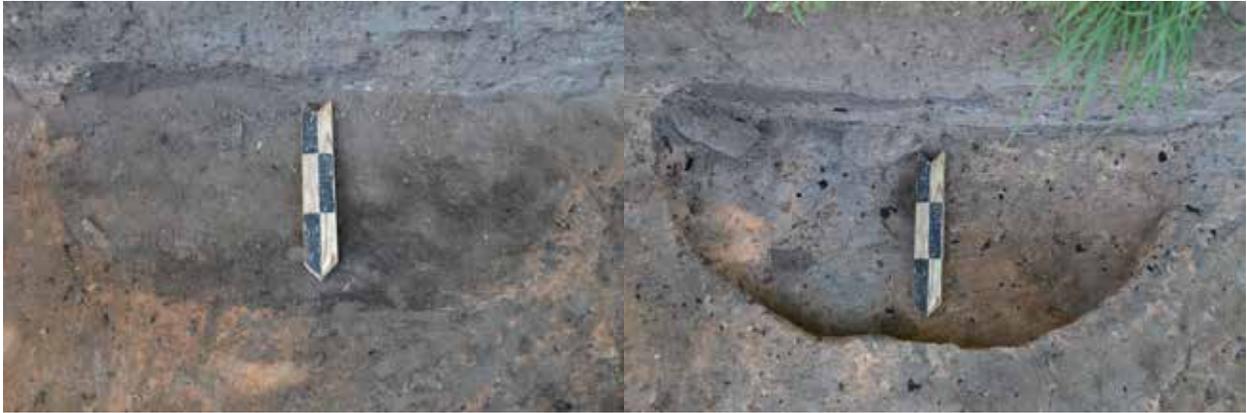
Figure 7. Pre- and post-excitation, Feature 1, Nonstructure 187 (view south), the Haynie site.

Nonstructure 187 is a surface identified in a 2-x-2-m unit. This surface had been created in a deposit of construction material that was impacted by mechanical disturbance and by the installation of a modern irrigation system in the western portion of the unit. A pit feature, Feature 1 (Figure 7), had been dug into this surface. The top of the feature had also been disturbed by mechanical activity in the west great house and by the creation of the modern lawn (Figure 8). The few artifacts collected from Feature 1 included sherds, flaked-lithic debitage, and nonhuman bone.

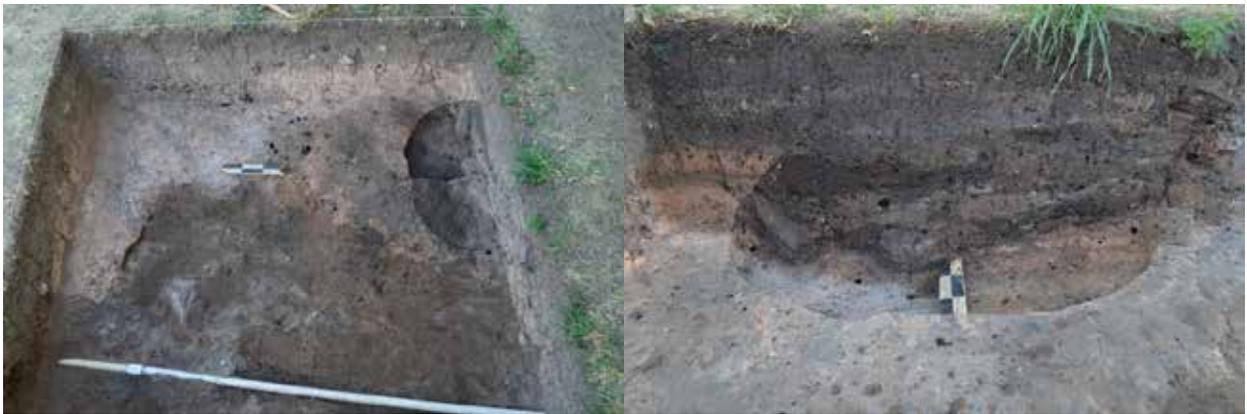
Figure 8. Impact of mechanical disturbance on Feature 1, Nonstructure 187, oblique and profile views, the Haynie site.

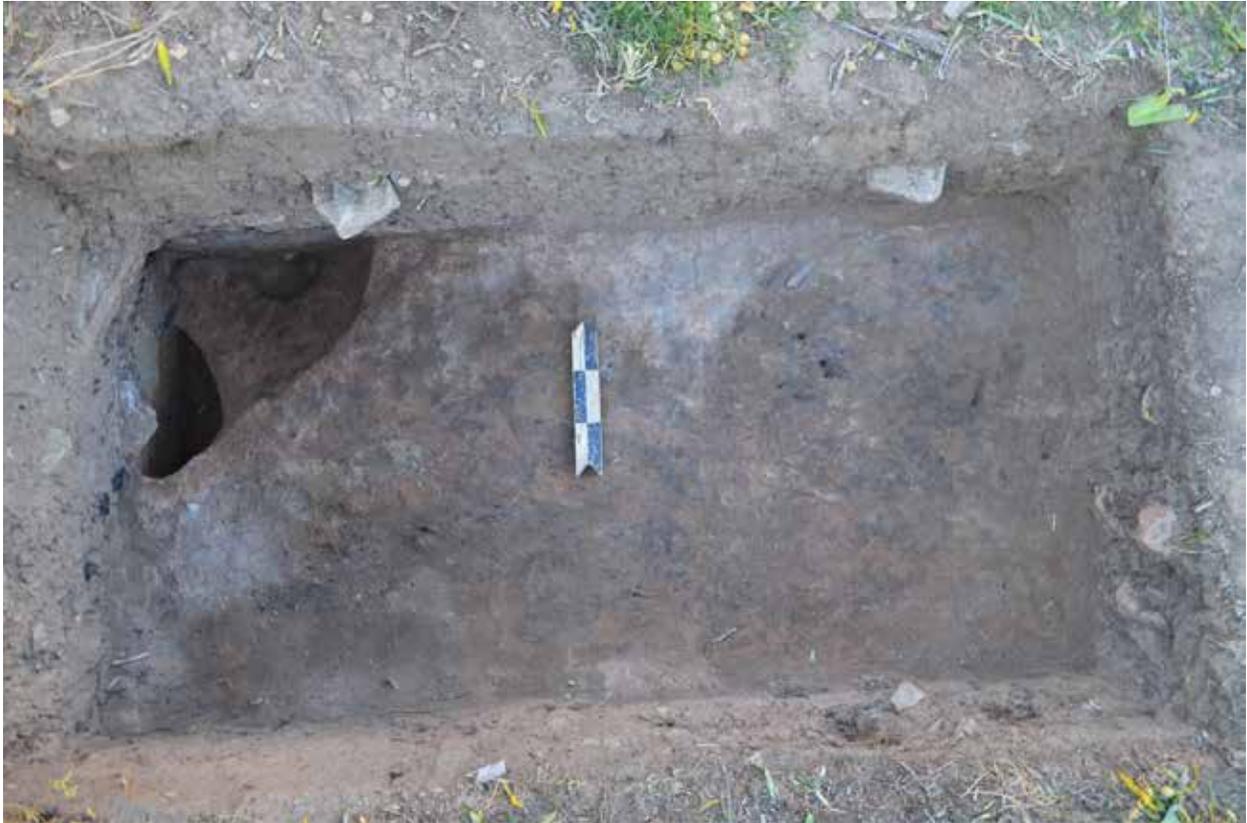
Figure 9. Nonstructure 191 surface in a 1-x-2-m unit south of the remains of the west great house (view north), the Haynie Site.

Nonstructure 191 is a surface identified in a 1-x-2-m unit (Figure 9) and consists of compacted native sediment beneath the west great house. As evidenced by backhoe scars, the surface and the sediment above this surface had been disturbed by previous digging in the great house. Despite the disturbance, small portions of two pits, Features 1 and 2 (Figure 10), which had been dug into undisturbed native sediment, were defined. Feature 1 is a shallow pit with a small depression. Feature 2 had been dug into Feature 1.

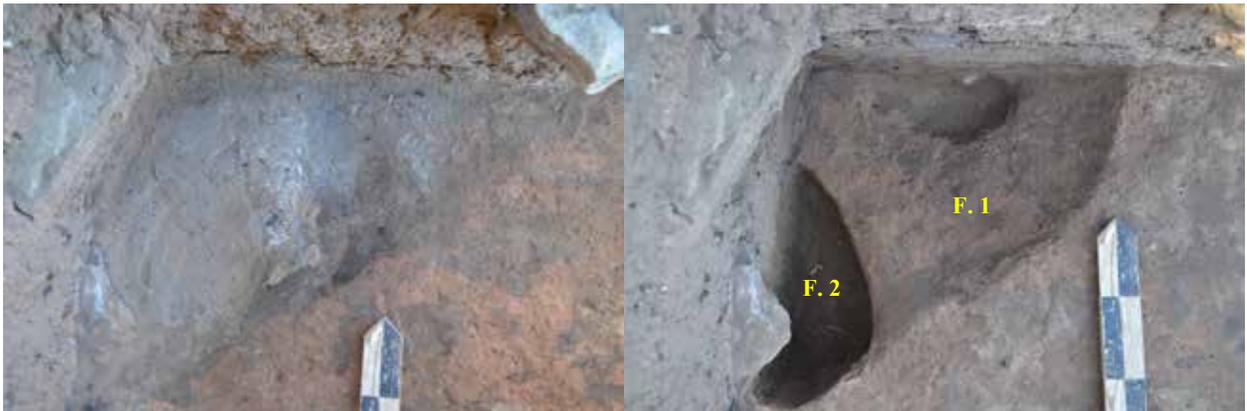
Figure 10. Pre- and post-excitation, Features 1 and 2, Nonstructure 191 (view north) the Haynie Site.

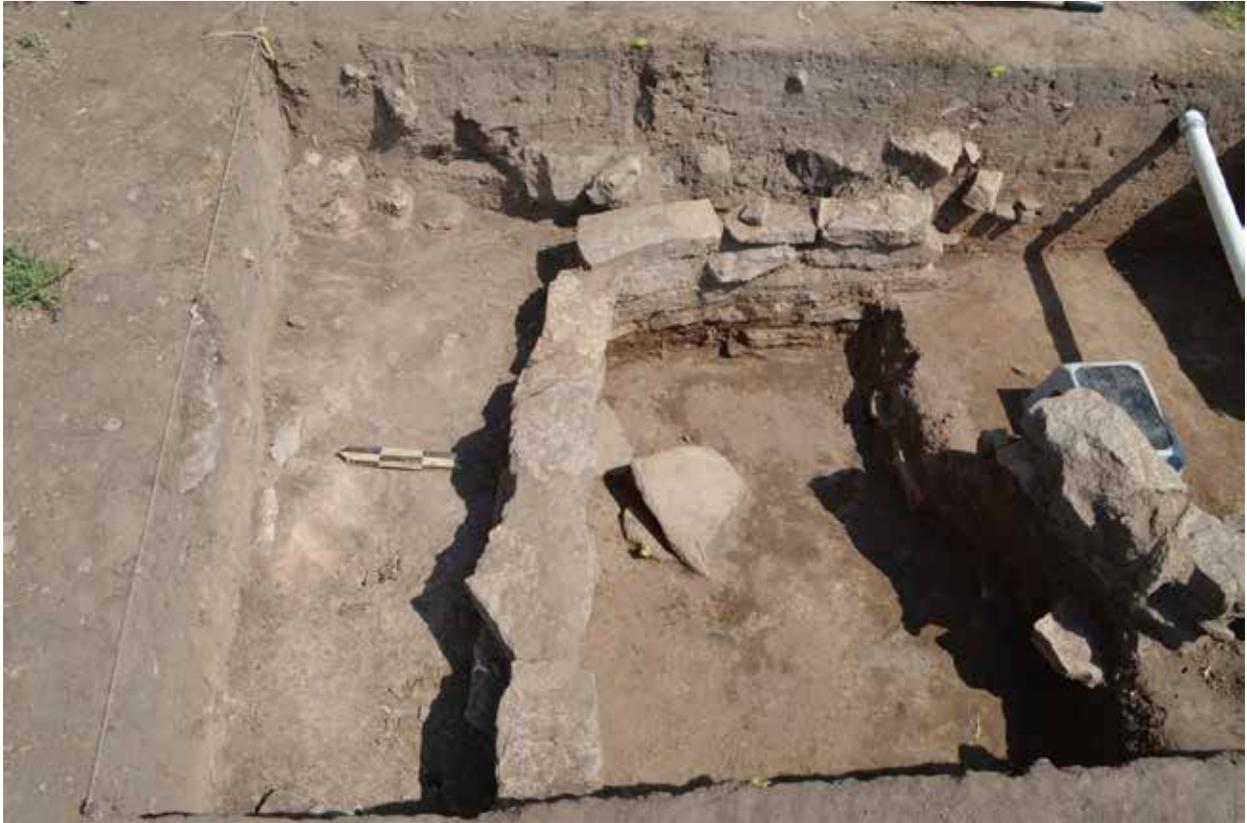
Figure 11. Oblique view of the Structure 193 north and east wall segments (view east), the Haynie site.

Structure 193 is a room constructed of single-coursed masonry located directly west of the modern house. The northern wall of the room was identified in two 1-x-1-m units—one was randomly selected to investigate the deposits west of the modern house, and one was selected to investigate the northern wall (Figure 5 and Figure 6). The wall consists of rectangular sandstone blocks and mortar, and the wall arcs to the southeast (Figure 11). The trajectory of the wall suggests that the interior is approximately two meters wide (east-west); the exact measurement will be revealed by excavations to the south and west in 2018. The floor was not prepared. Structure 193 experienced disturbance in both ancestral-Pueblo and modern times: Structure 186 had been constructed within Structure 193, and a laundry-drainage pipe was recently installed roughly east-west through the center of the room. The southwest portion of the room will be excavated in 2018.

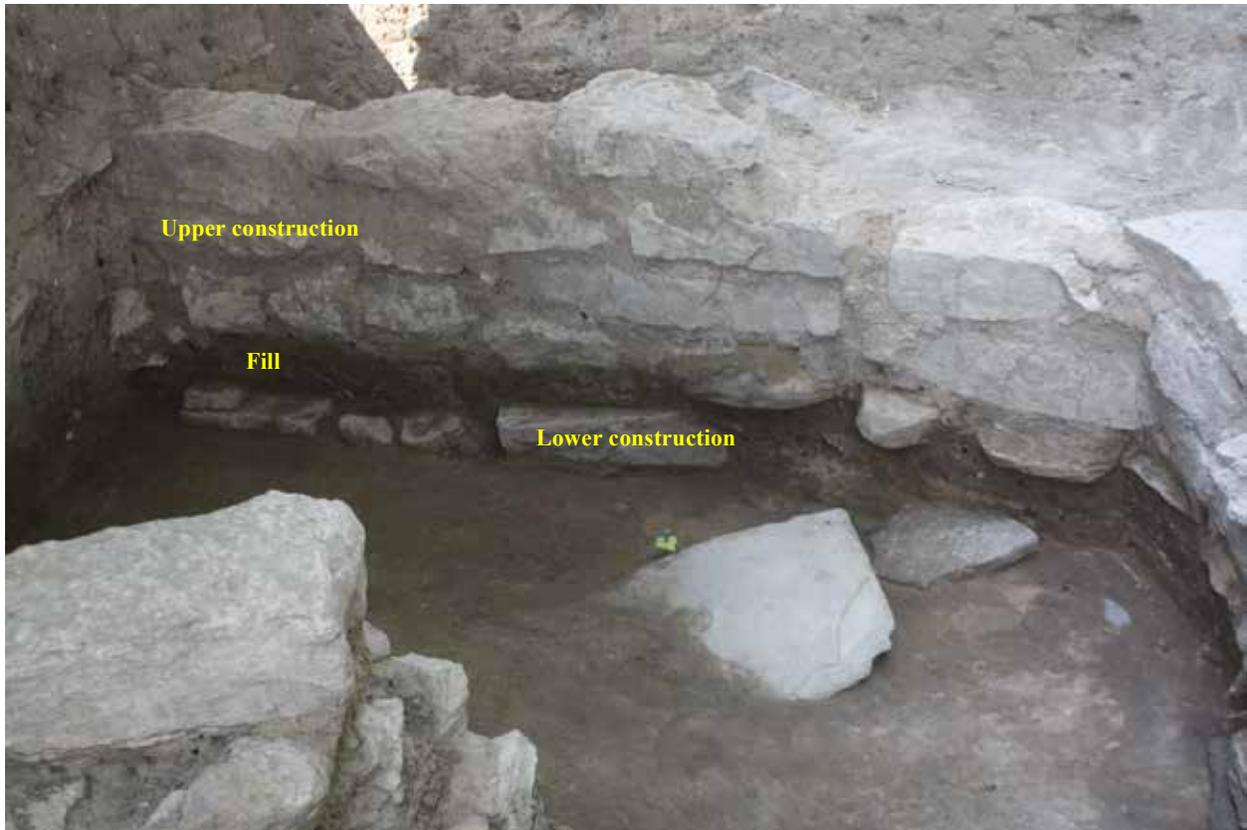
Figure 12. The interior face of the north wall of Structure 193, the Haynie site. Note upper construction (rectangular blocks), underlying fill, and lower rock alignment.

Beneath the upper portion of the north wall (Figure 12) is a layer of construction fill. Under this fill is an alignment of sandstone rocks. These stones appear to create an arc to the northeast rather than follow the trajectory of the upper wall. Excavations in 2018 will seek to determine if these stones represent footer construction associated with the upper portion of the wall or a different construction that predates both Structures 186 and 193.

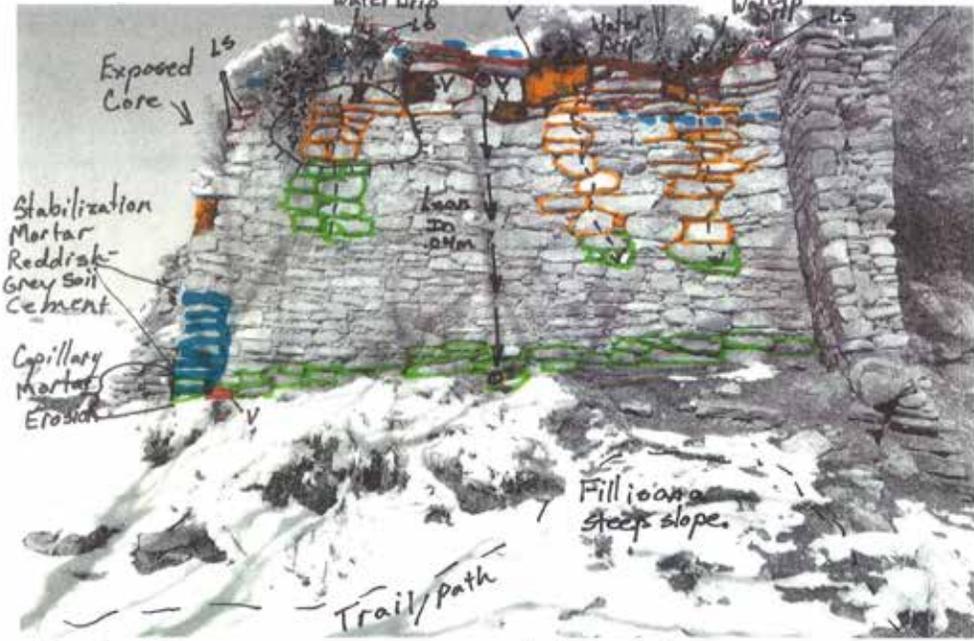
Figure 16. Condition assessment annotation for the interior face of the north wall of Room 163 in the west great house, the Haynie site.

Cap:
 Suffering from
 - Unprotected mortar cap.
 water entering wall through holes.
 - Vegetation displacing stone.
 - Mortar erosion moderately severe.

- No leans. No threat.
- Small vertical bulge. Low.
- No cracks. No threats.
- Moderate fill pressure from behind. Low.

- Cap open and eroding and veg damage. Severe
- Loose stones in caps. Severe.
- Water runoffs causing mortar erosion. Moderate.
- Capillary mortar erosion along base. Severe.

The north wall of Room 163 in the west great house is the tallest exposed masonry wall at the Haynie site. It stands 2.5 m tall, is 4.73 m long, and towers over the central rear section of the west great house, which is an area of particular interest in NCOP research. A second veneer had been added to the exterior (north) face of the wall, which makes the wall extremely robust, but leaves the top of the wall susceptible to erosion. Our condition assessment found six small to medium voids in the upper courses of the interior face and at least seven loose stones along the current cap.

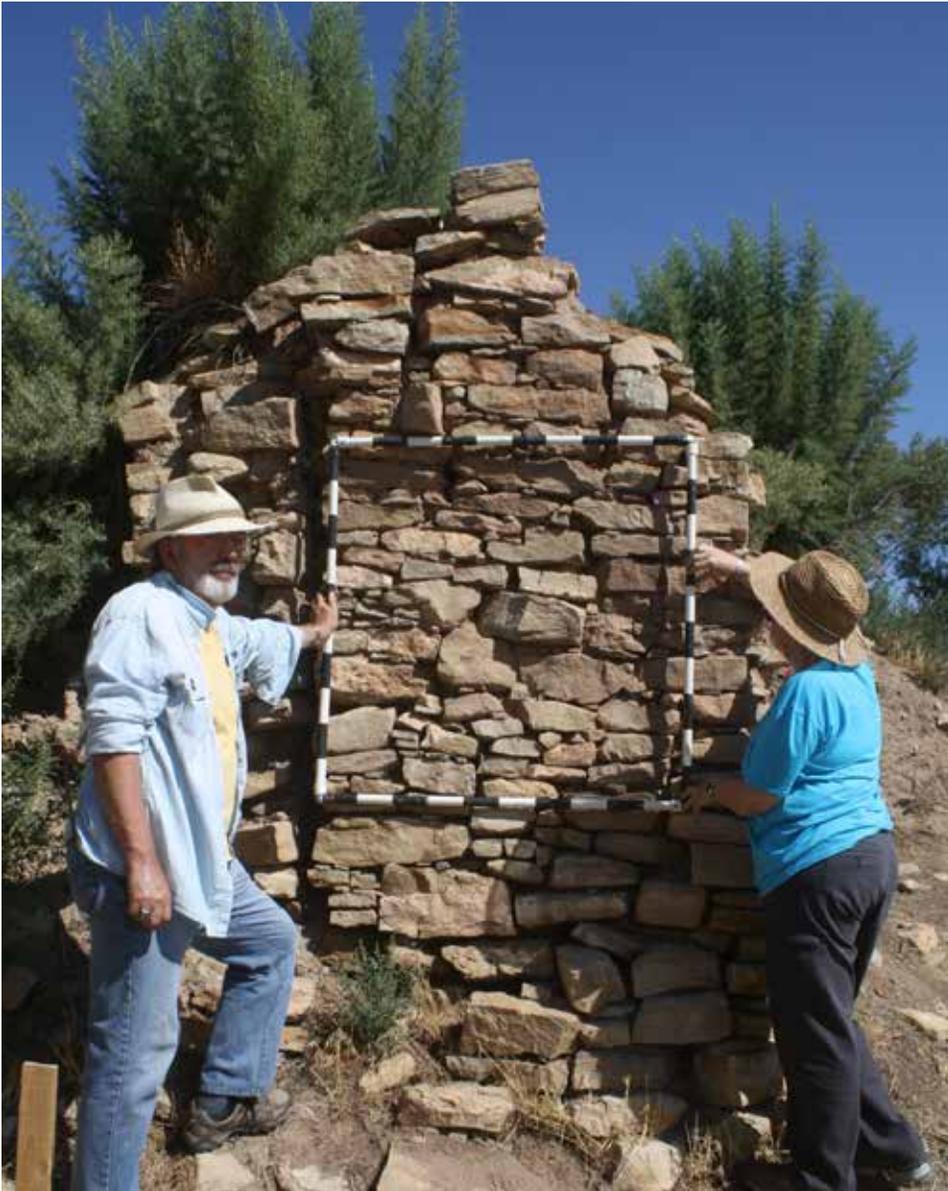
Figure 18. Veneer sampling of the remains of the west great house by Earthwatch Institute volunteers, the Haynie site.

To compare masonry-veneer styles observed at the Haynie site to veneer styles that have been documented at other ancestral Pueblo sites, Crow Canyon is collecting detailed measurements from each wall face. This is being done in accordance with the Intermountain Region National Park Service Architectural Documentation Sheet 3-Veneer Transects form (Nordby et al. 2008). Veneer sampling entails measuring the length of stones and of mortar gaps along each masonry course in a 1-x-1-m section of veneer (Figure 18). Crow Canyon will compare these data to veneer statistics of the National Park Service across the Southwest for locations such as Chaco Culture National Historic Park, Aztec Ruins National Monument, Mesa Verde National Park, Navajo National Monument, and Wupatki National Monument.

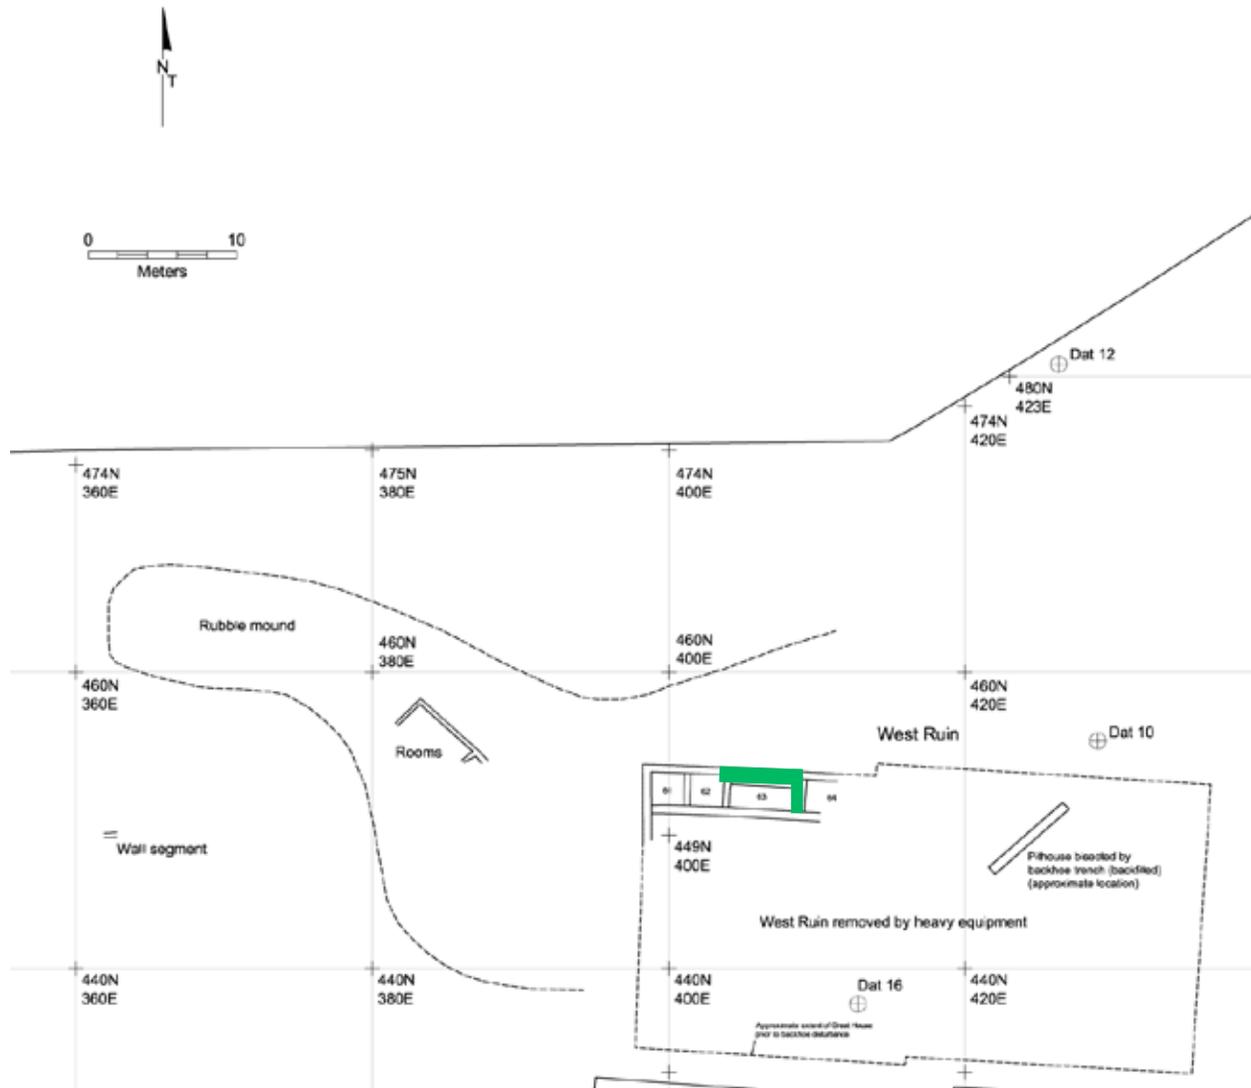
Figure 19. West great house, the Haynie site; masonry walls stabilized during the 2017 field season are highlighted in green.

Crow Canyon archaeologists stabilized exposed masonry walls that posed a threat to visitor and staff safety. Two walls (Figure 19 and Figure 20) in the west great house were stabilized in 2017 after their condition, construction, and mortars were documented in detail.

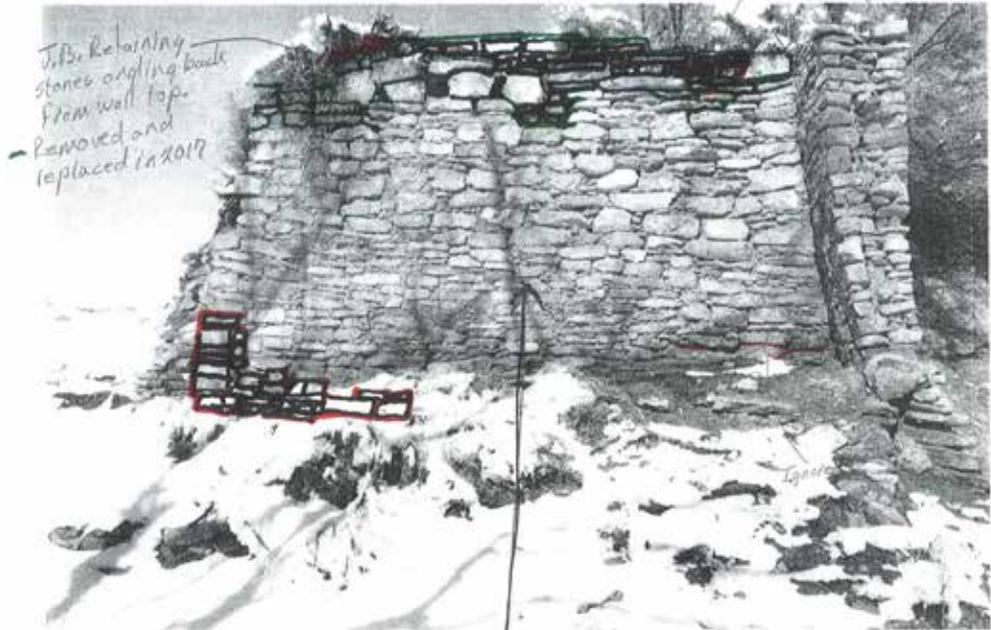
Fixed/Recessed stone
prior to 2019 repair.
Possible beam socket filled
with slab stone by
J. Bricker's

J. Bricker's
Rejoining
stones on top of
wall top.
Removed and
replaced in 2019

Added Stabilization
stone

Repair
2000-2003
J. Bricker's
Used pinkish brown
mortar with
high sand

Original north wall added
vencer mortar.
light brown compact sandy loess
with sporadic large charcoal
flecking.

Figure 20. Post-stabilization annotated photograph of the interior face of the north wall of Room 163 in the west great house, the Haynie site.

In 2017, the north and east walls of Room 163 were partly capped to increase the stability of the walls. In the north wall (Figure 20), three large stones were reset, six voids were filled, two courses of stone were added to the top of the veneer, and a small section of veneer was repointed. In total, 31 stones and 12 gallons of mortar were used to stabilize the wall cap. The east wall was entirely recapped to halt the erosion of mortar from the core. Twenty stones were reset and 14 new stones were added to seal the cap. A total of 6 gallons of mortar were used to repair the cap of the east wall. The stabilization mortar consisted of 50 percent reconstituted mortar collected from “melted” mortar in the top of the wall, 45 percent light brown silt from alluvial deposits along the south boundary of the Haynie property, and 5 percent Portland cement.

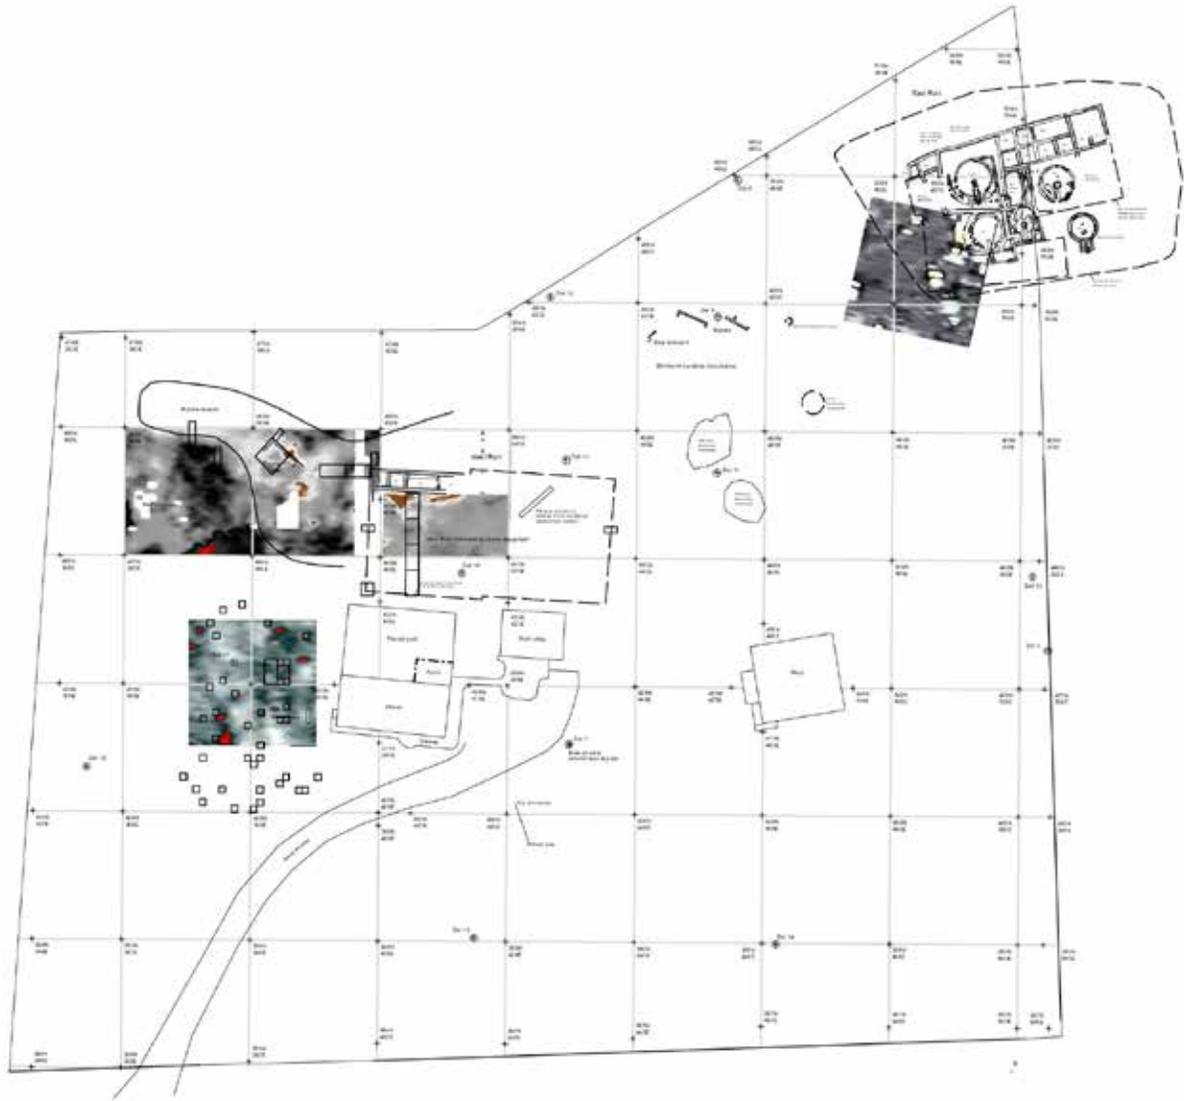
Figure 21. Locations of geophysical grids on the Haynie site (5MT1905).

The geophysical survey for the 2017 fieldwork was conducted with two Geoscan products: a RM15 Electrical Resistance Meter and a FM36 Fluxgate Gradiometer. Grids for the electric resistance survey were aligned to true north, whereas grids for the fluxgate gradiometer were aligned to magnetic north. At the Haynie site, the magnetic north is about 11 degrees east of true north. Each grid in both surveys measured 20-x-20 m. Five grids were surveyed with the electrical resistance meter, and one grid was surveyed with the gradiometer (Figure 21). Weather and soil conditions changed throughout the collection period but were not unusually wet or dry at the time of the surveys.

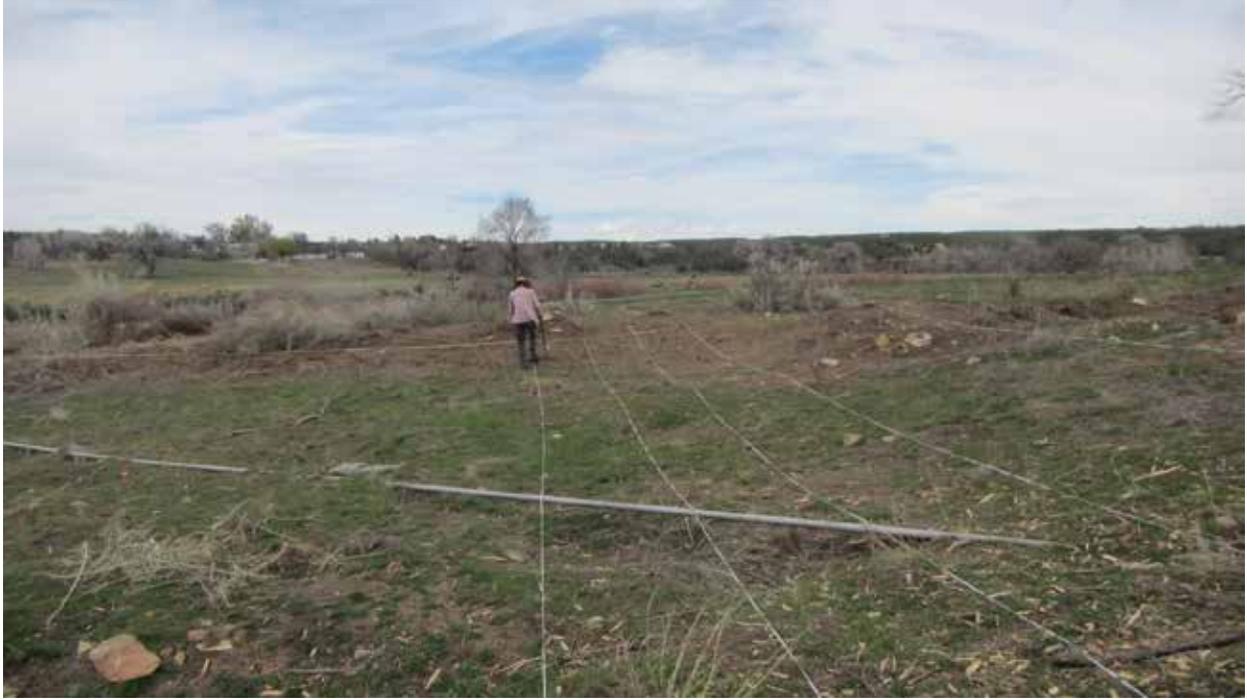
Figure 22. Supervisory archaeologist Caitlin Sommer conducting electrical resistance survey in the northwest portion of the Haynie site, view north.

Electrical resistance survey works on the principle that anomalies beneath the modern ground surface can be detected because their resistance to the flow of an electrical current deviates from the surrounding norm. The survey at the Haynie site (Figure 22) measured the distortion of an induced electrical field caused by subsurface phenomena such as archaeological structures or features. Grids 1, 2, and 3 (Figure 23) encompassed an area in the northwestern portion of the site where a wall that is apparently independent of the remains of the west great house had been exposed by previous mechanical digging. In the northern portion of Grid 1, a large oval area with relatively high resistance and two specific anomalies was detected. These anomalies may represent historic or prehistoric cultural deposits. Alternatively, the anomalies may represent bedrock that is fairly deep subsurface; that is, if the bedrock was shallow, the resistance values would be much higher.

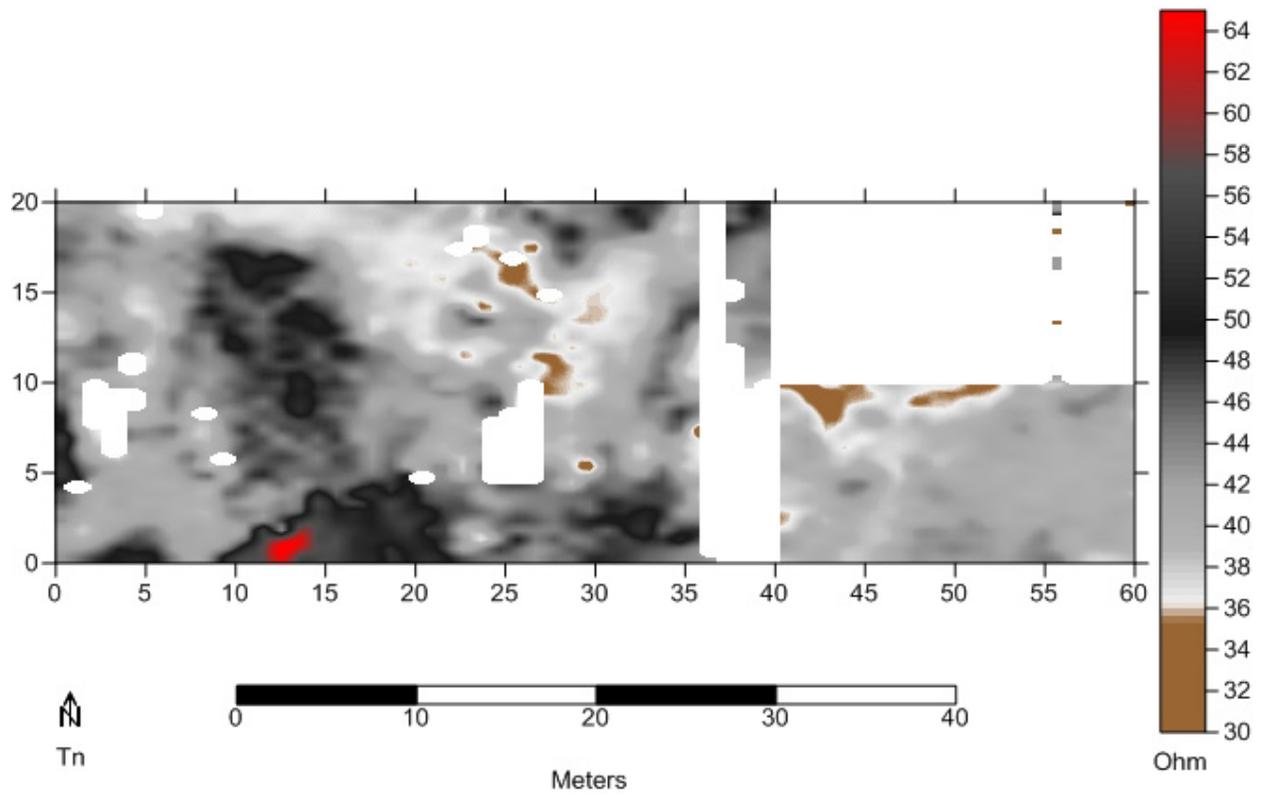
Figure 23. Electrical resistance survey Grids 1, 2, and 3 at the Haynie site. Image created by Mona Charles, Powderhorn Research LLC, 2017.

Auger testing in the two identified anomalies indicate substantial depth to the deposits (greater than 1.5 m), and subsequent test trenching indicates the presence of possible structures that might have been impacted by mechanical digging and the modern occupation of the site. An aboveground water line that fed a sprinkler system was removed from the area just south of Grids 1 and 2. The resistance data did not show any clear effect from this water line. Because of extensive previous digging and the necessity to dummy-log large portions of the grids, Grids 2 and 3 did not yield definitive data.

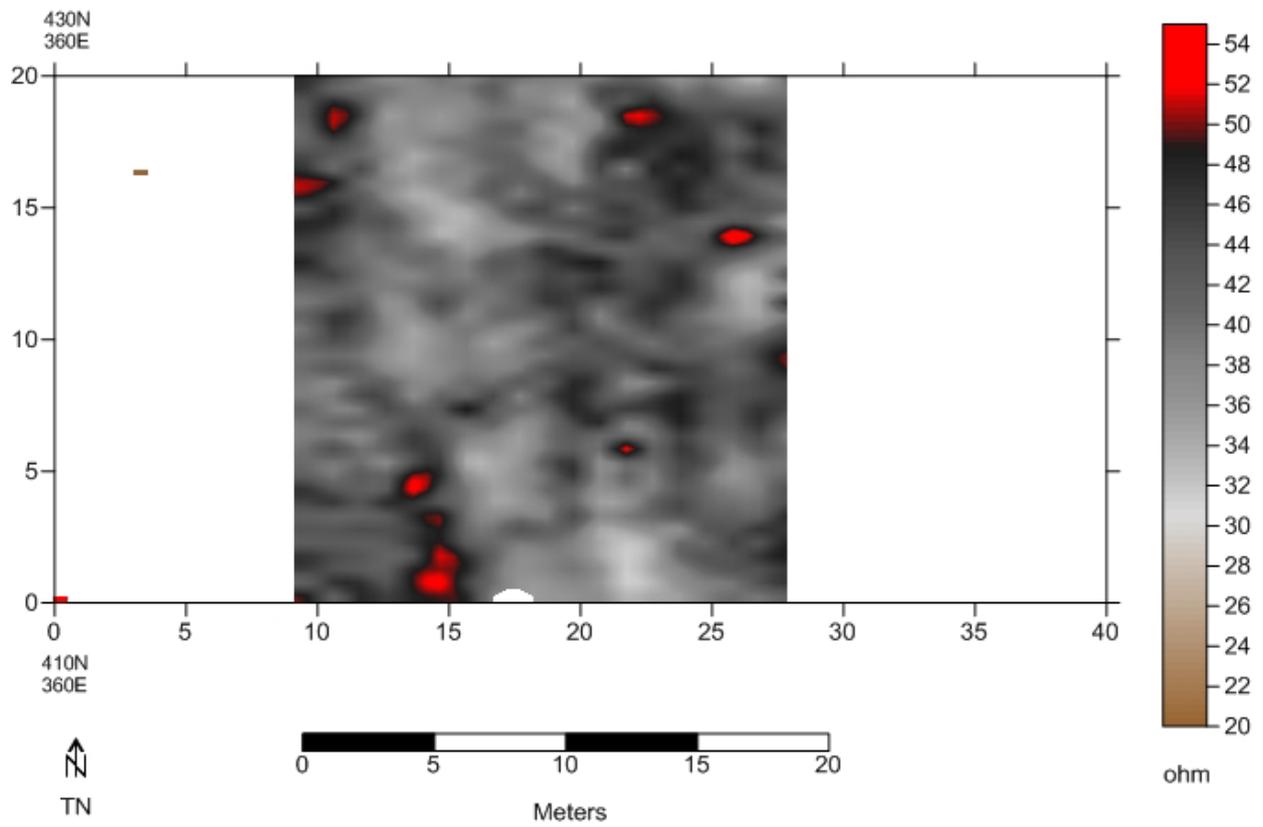
Figure 24. Electrical resistance survey Grids 4 and 5, the Haynie site. Image created by Mona Charles, Powderhorn Research LLC, 2017.

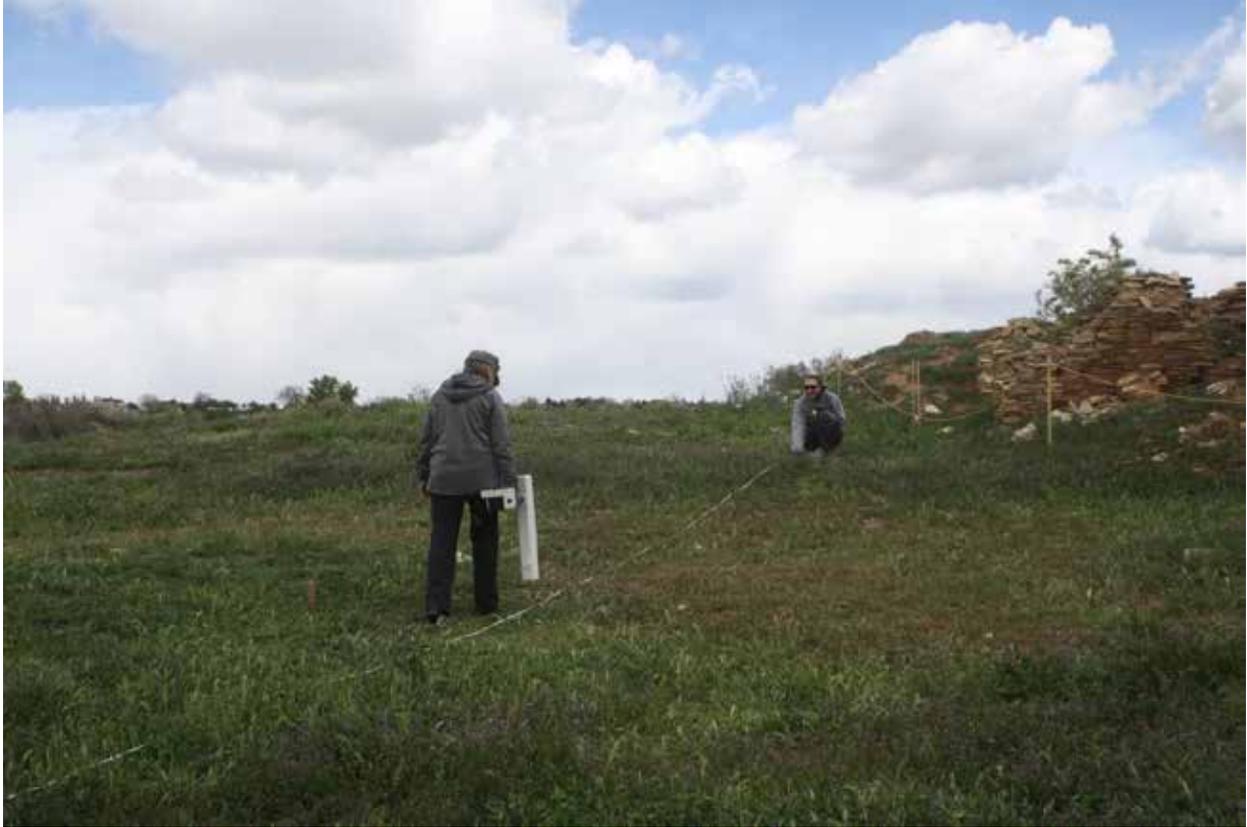
Figure 25. Mona Charles conducting gradiometer survey west of the east great house with Crow Canyon field archaeologist Rebecca Simon assisting, the Haynie site.

One grid just southwest of the east great house was surveyed with a gradiometer (Figure 25). This instrument works on the principle that buried artifacts, features, or differences in sediments and soils produce minute variations in the earth's magnetic field. The gradiometer measures the strength of the earth's magnetic field in different locations and records variations in those values. The gradiometer survey isolated at least two linear anomalies—one that extends east-west across the bottom of the grid, and another that is oriented diagonally in the northwest corner of the grid (Figure 26). The east-west linear anomaly follows the basic outline of the great house as illustrated on a map produced before the east great house was damaged in modern times (Figure 15). The diagonal anomaly in the northwest corner of the grid projects toward the northwest corner of the east great house and the northwesternmost kiva (Figure 21) in that great house. This anomaly may indicate a buried prehistoric feature related either to the great house or to an earlier occupation. Alternatively, the linear anomalies could be reflect one or more activities that occurred during previous digging in this portion of the great house such as historic pedestrian paths, wheelbarrow paths, or heavy equipment paths, or even indicate buried utility lines. Additional testing of this area will occur in the 2018 and 2019 field seasons.

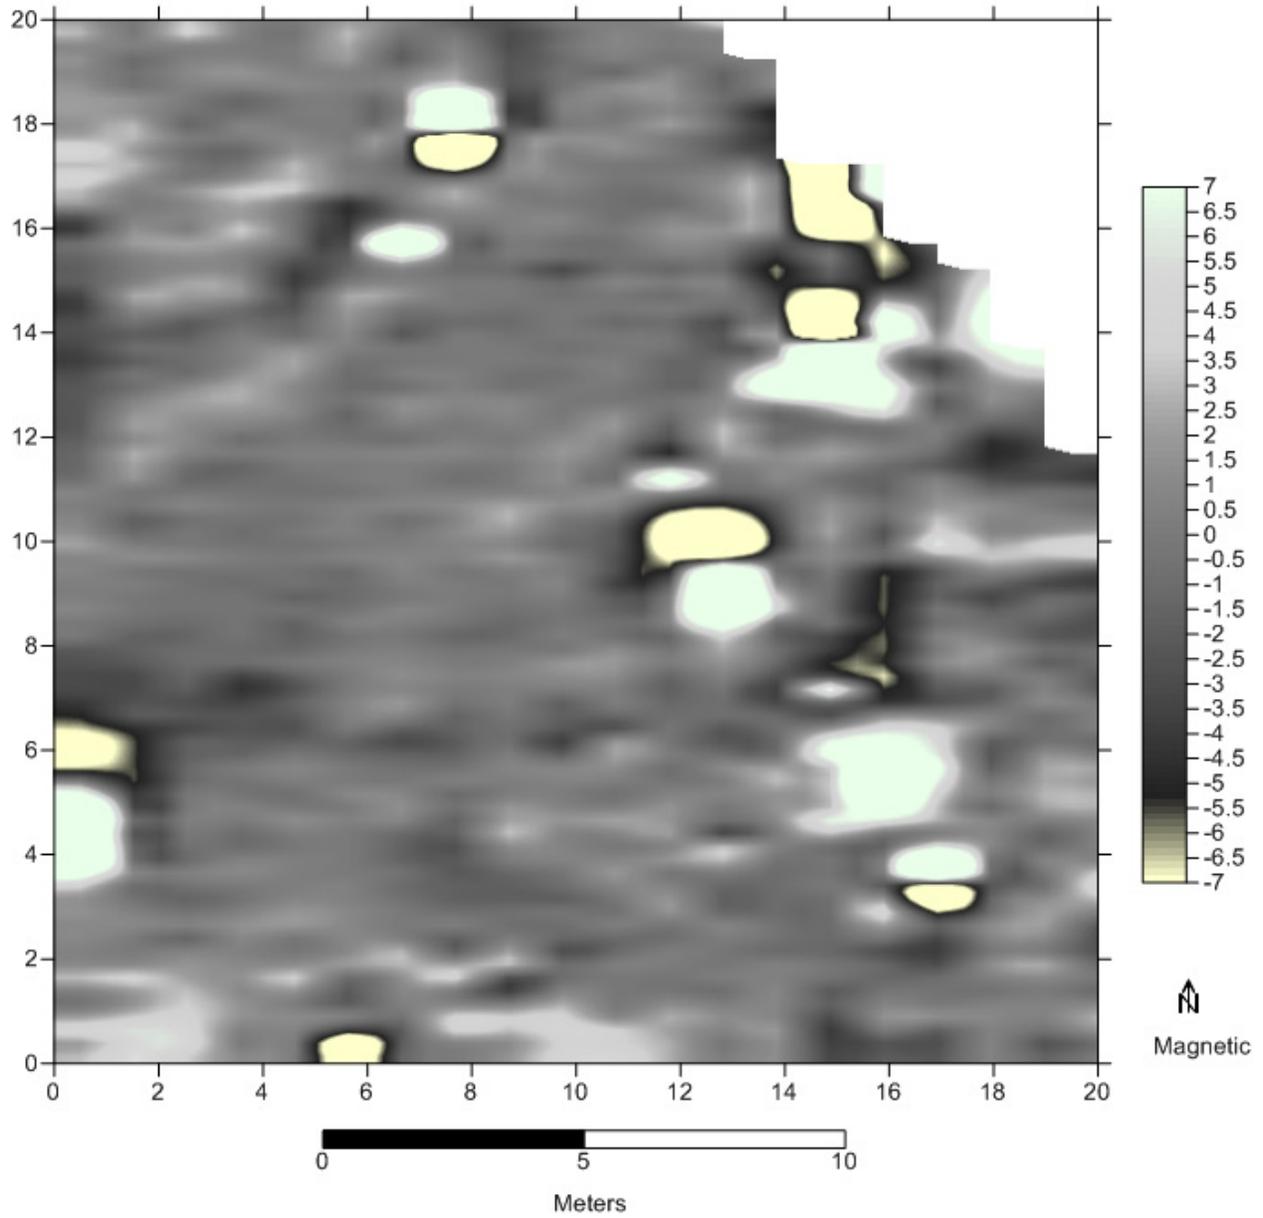
Figure 26. Gradiometer survey Grid 1, the Haynie site. Image created by Mona Charles, Powderhorn Research LLC, 2017.
